**PILOT POINT  
HOMEOWNERS' ASSOCIATION, INC.**

**REPLACEMENT RESERVE STUDY**

**2003**

PILOT POINT  
Lewes, Delaware  
May 30, 2003

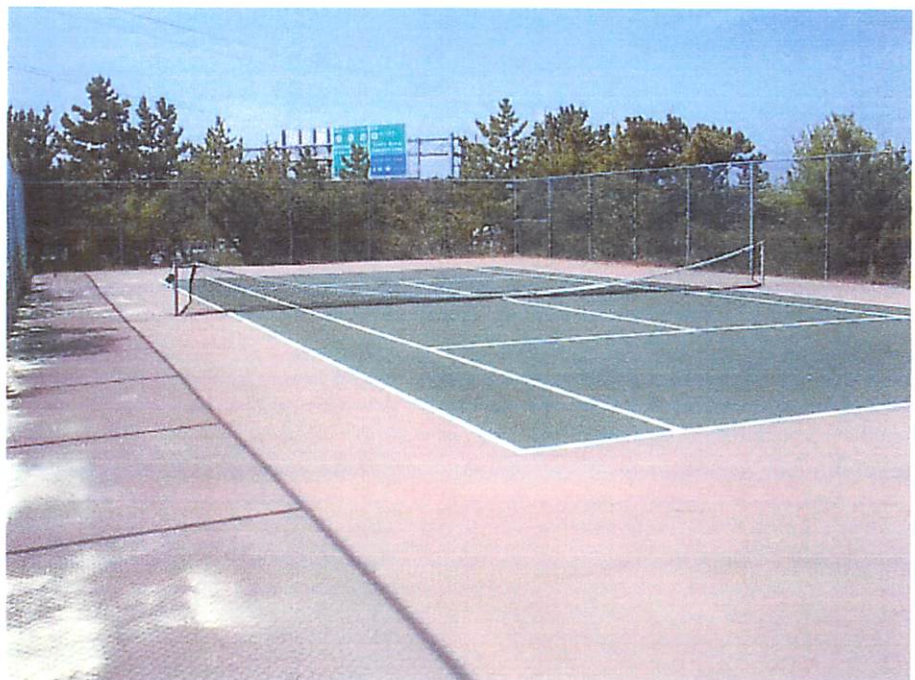
**Photo #17**

**Tennis Courts.** A fresh color coat was recently applied to the surface of the tennis courts. Because the courts are built on sand the cracks have re-opened in the surface. See Photos 17, 18 and 19. We recommend consideration be given to patching the cracks as an interim repair with a system such as the Armor Crack Repair System. Information on this system can be found at [www.armorcrackrepairsystem.com](http://www.armorcrackrepairsystem.com). Cost is approximately \$20 per foot of crack. In approximately five years, when the courts are due to be re-surfaced again we recommend an overlay with 1" of #10 screen crush rock and a 2" lift of asphalt. Local installer of this system of bridging cracks include T&A Engineers at tel: 302-846-3350.

Severe Cracks in Tennis  
Court Surface

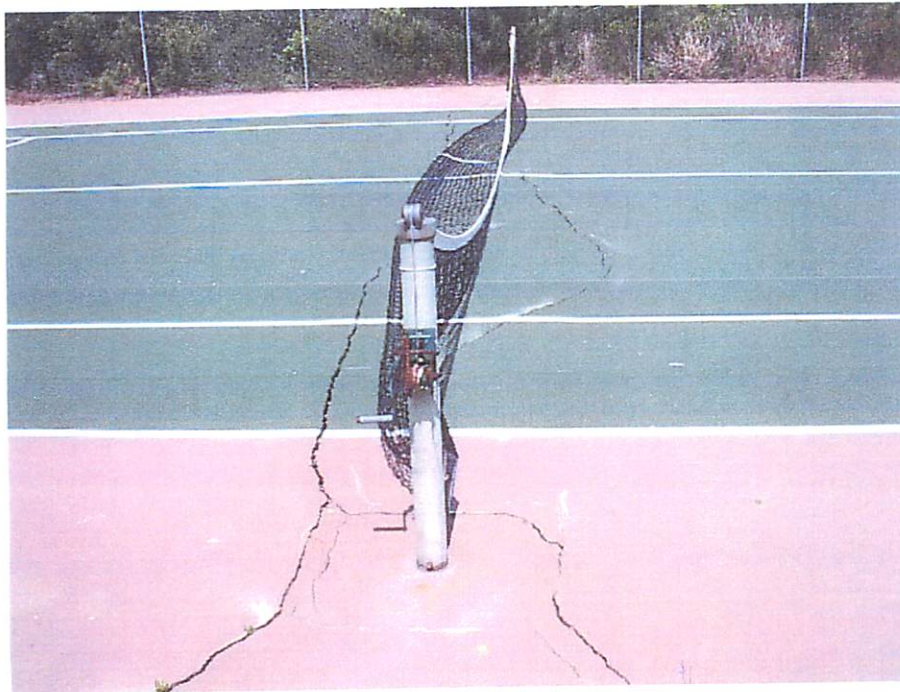
**Photo #18**

Severe Cracks in Tennis  
Court Surface

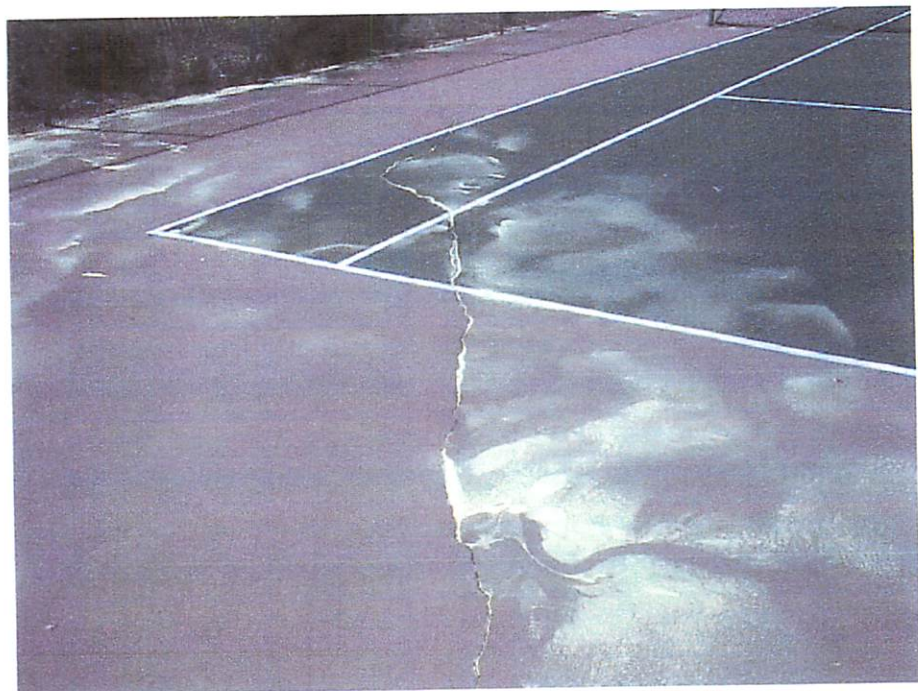
**Photo #19**

Severe Cracks in Tennis  
Court Surface

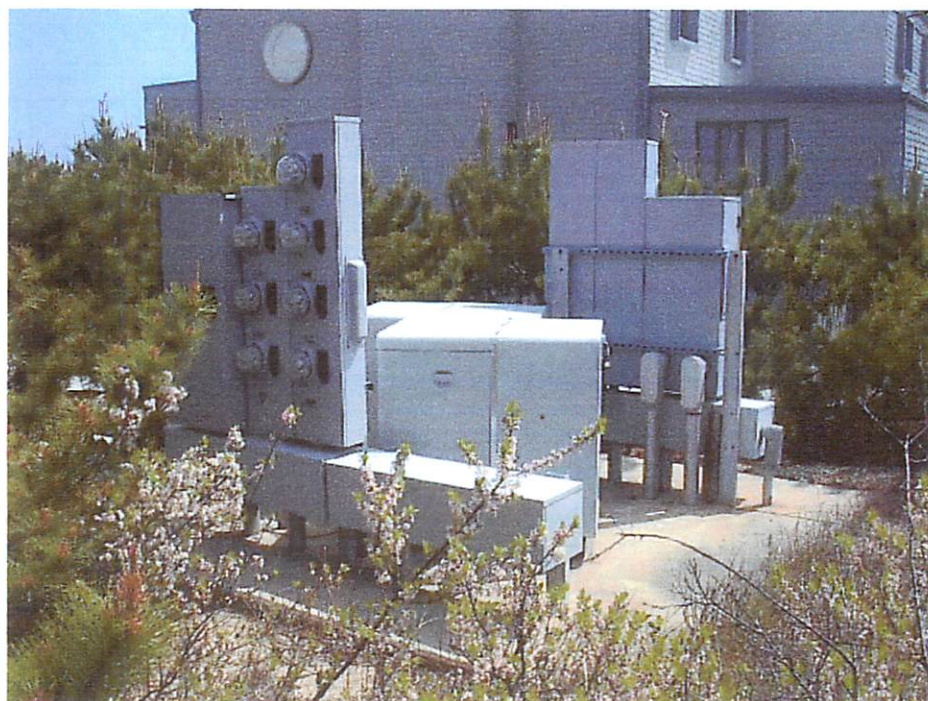
**Photo #29**

The service laterals, since they are not in conduit (see photos), need to be a minimum of 24" below grade (NEC Table 300-5) unless there is some concrete protection above them then they could be 18". Where the services come up from underground into the meters they need to be protected. NEC 300-5 (d) says rigid metal conduit, intermediate metal conduit, schedule 80 PVC, "or equivalent". Schedule 80 is heavy wall PVC. If the installers used something lighter, that could be a code violation unless the local "authority having jurisdiction" approved schedule 40 as "equivalent".

Underground Wiring at  
Phase 3 Distribution  
Center

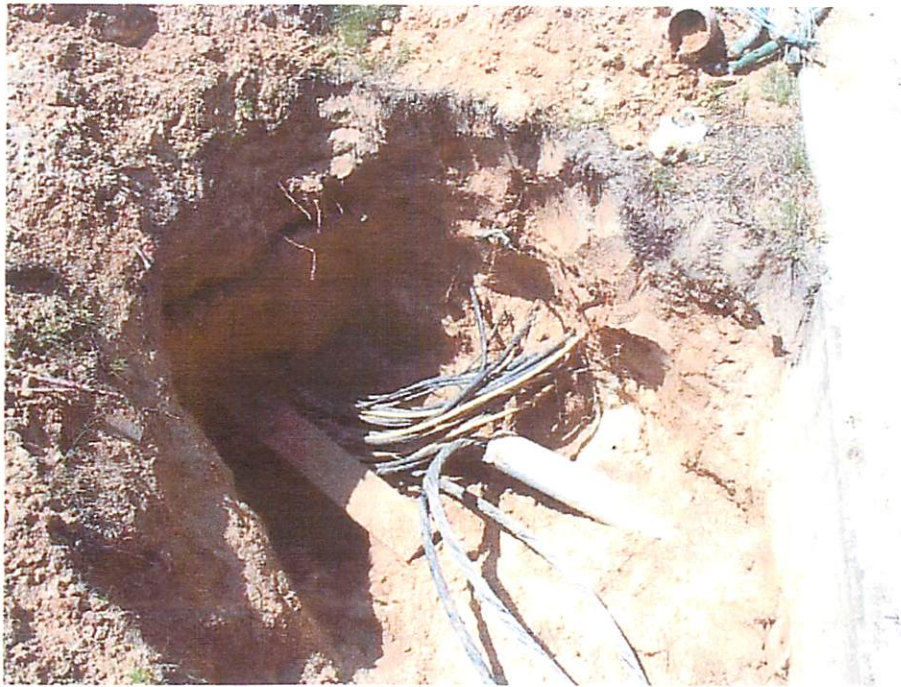
**Photo #30**

Underground Wiring  
at Phase 3 Distribution  
Center

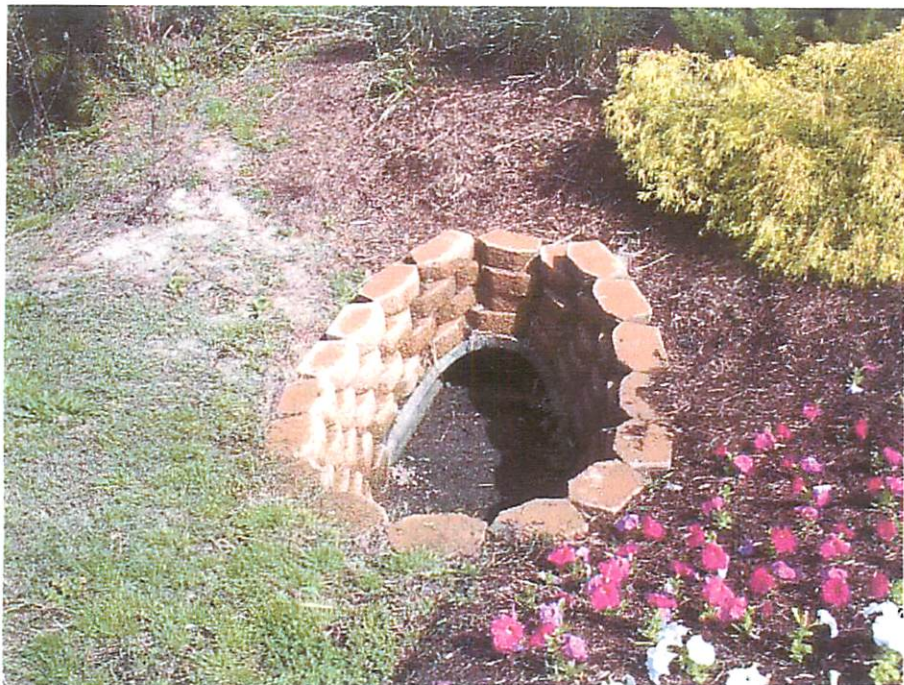
**Photo #35**

Because of the relatively flat terrain, fall in the storm waterlines and the drainage swales outside the community is limited. We understand that storm water commonly backs up into the system at Pilot Point, which leads to siltation of the lines. See Photo 35, which is the discharge point at the entrance to the property. This condition should be brought to the attention of the local authorities.

Storm Drainage Outlet –  
Note siltation.

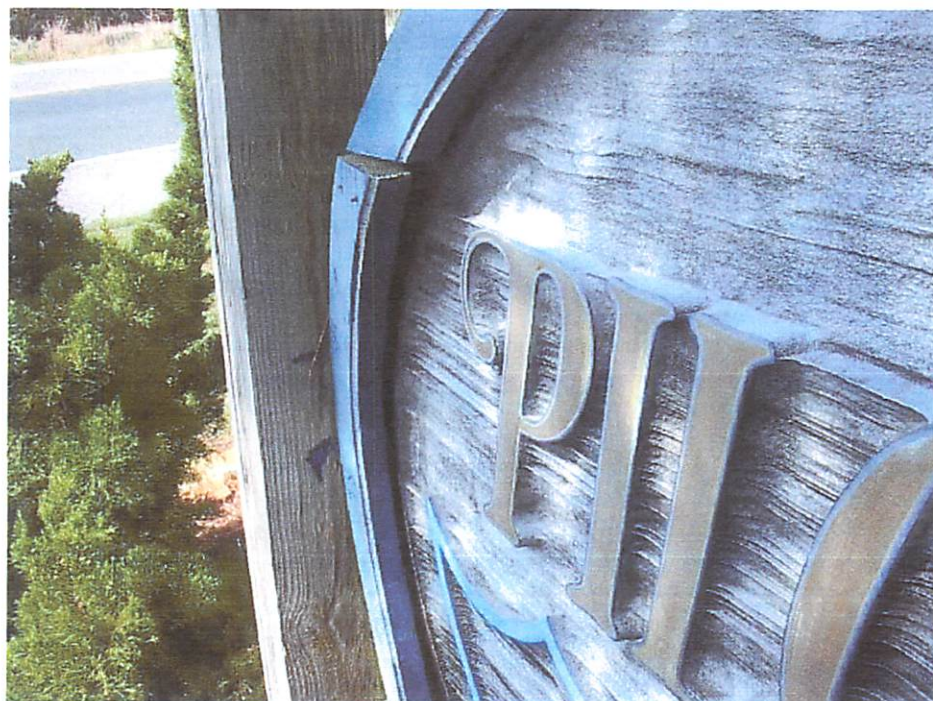
**Photo #34**

Community Sign –  
Repair needed.
